EXPERIMENTAL INVESTIGATION OF RIM CRACKING IN DISKS

SUBJECTED TO HIGH TEMPERATURE GRADIENTS

By P. I. Wilterdink

WASHINGTON
September 1, 1949

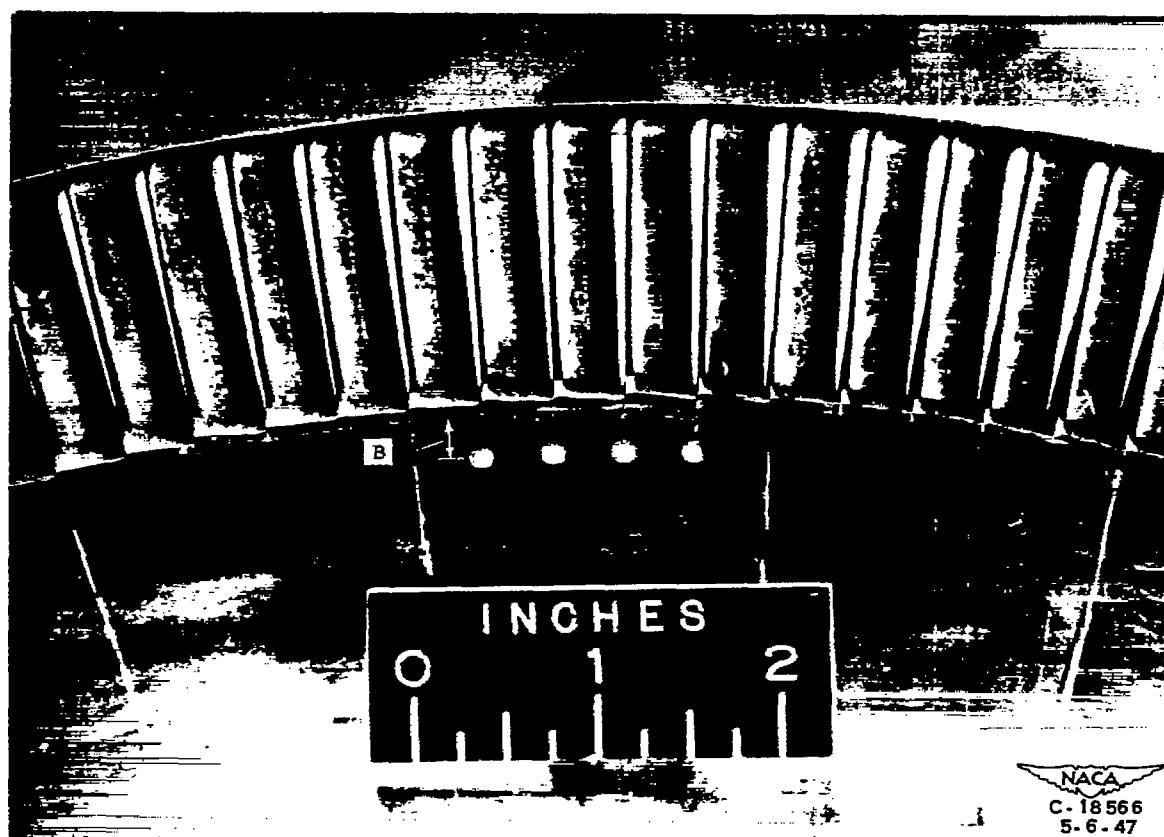
Figure 3. - Hole locations in gas-turbine wheel rim.

Effectiveness of holes in stopping crack growth. - The growth of the cracks at the locations where holes were drilled is shown in table II. Seven cracks progressed to the holes during the runs, but it was impossible to cause these cracks to progress beyond the holes. After 30 thermal-stress cycles, four cracks appear to have gone from the holes to the region beyond the holes. Figure 7 shows that for a given crack there is some variation between the upstream-side and downstream-side crack length. The crack length in the interior of the rim, between the two outside surfaces, may have been different from the crack length measured on either surface. Probably the four cracks that appear to have gone from the holes to the region beyond the holes actually extended beyond the holes in the interior of the rim at the time the holes were drilled. If any part of a crack actually extended beyond the hole at the time the hole was drilled, the hole naturally would not be effective in stopping crack growth.

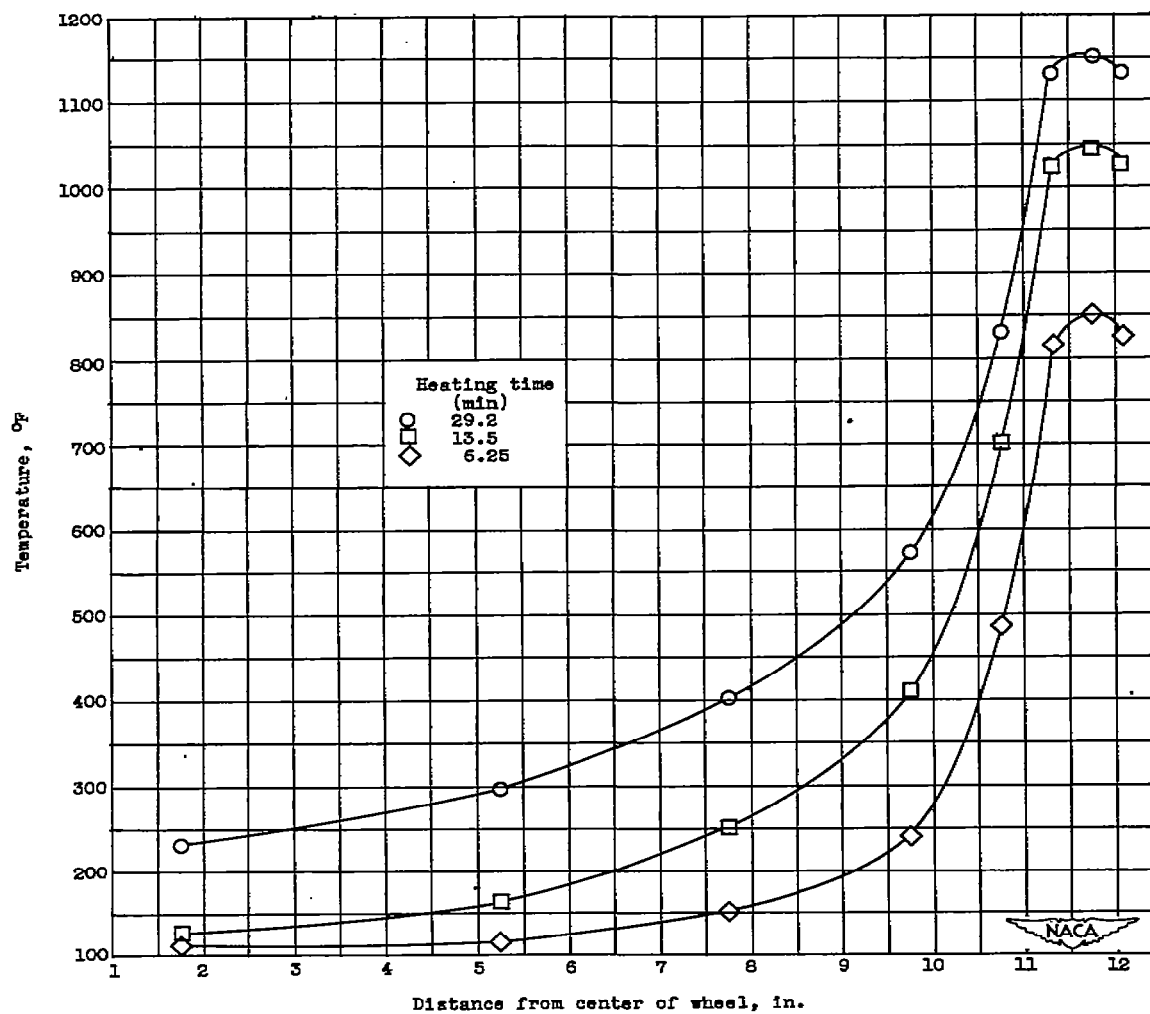
Figure 5. - Temperature distribution in gas-turbine wheel during heating.

The thermal-stress cycle consisted in heating the rim of the turbine wheel to 1150°F in approximately 25 to 30 minutes and then cooling the wheel by means of fans on both sides of the wheel. The temperature distribution during heating is shown in figure 5 and the temperature distribution during cooling is shown in figure 6. The rim of the wheel cooled very rapidly during the early part of the cooling cycle. After $1/2$ hour of cooling, the maximum temperature in the wheel was approximately 220°F and the minimum temperature was approximately 170°F . The minimum cooling time was 1 hour, after which the temperature in the wheel was 100° to 150°F . During the process of heating, the edges of the holes and the cracks became red a few seconds before the main part of the rim, but this difference was not believed to be a serious effect.

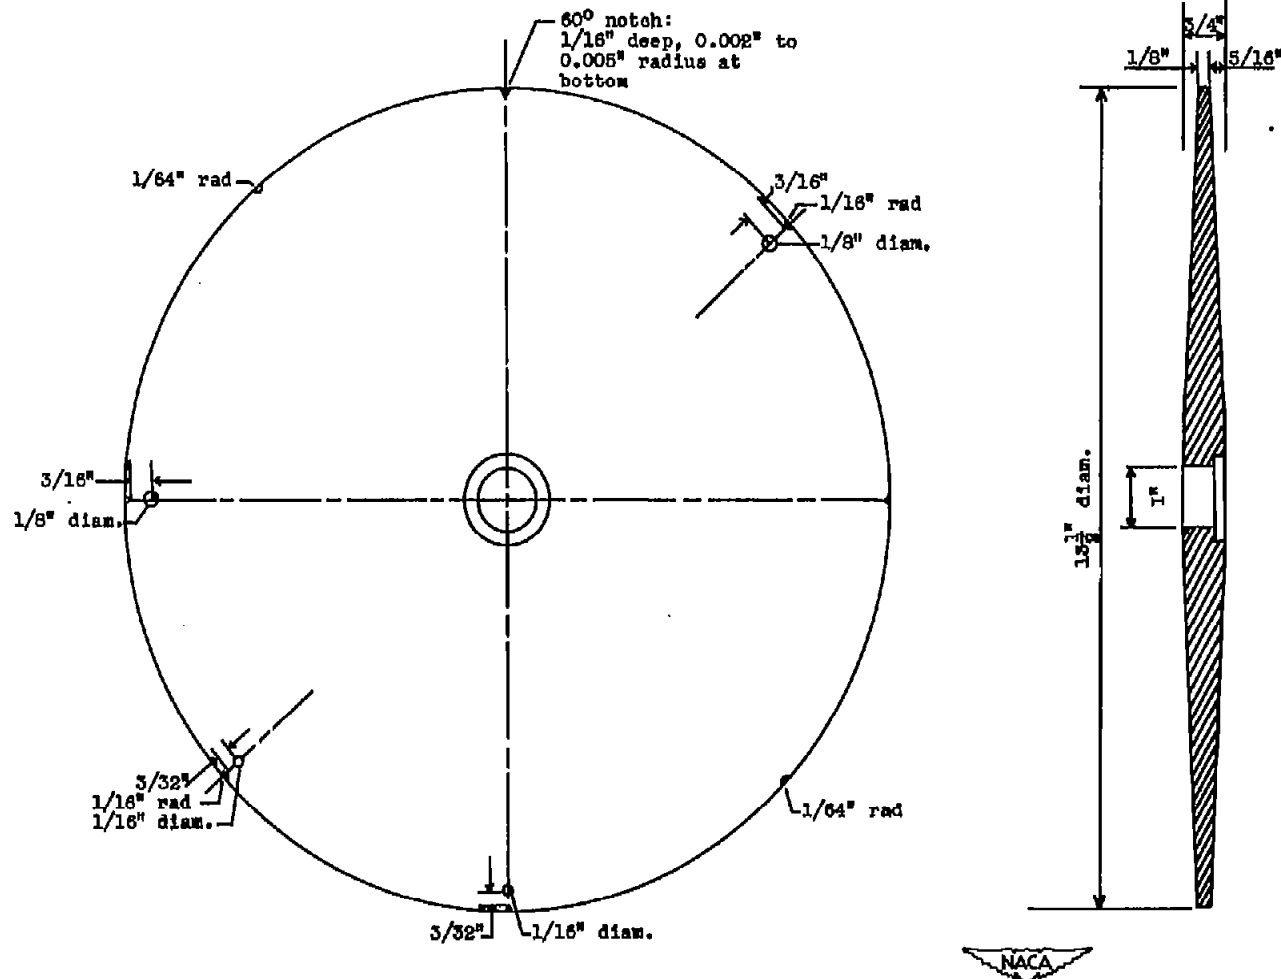
Figure 14. - Notched- and drilled-rim 13.5-inch-diameter tapered tool-steel disk.

Occurrence of cracks. - With one exception, the first crack occurred between the 60°-V notch and the 1/16-inch-diameter hole. The relation between the holes and the notches is shown in figure 14. In most cases, within a few cycles after the first crack occurred and at the same temperature gradient, cracks occurred at the remaining V notches irrespective of the presence of holes. With two exceptions, no cracks occurred between the semicircular notches and the holes. In the case of the V notches without holes, the cracks generally grew about 1 inch during the cycle in which they occurred. This initial growth seemed to occur in a very short time or instantaneously. During the cycle at which the crack passed through the hole, the crack length increased about 1/4 inch. The crack lengths increased very slowly after the cycle during which they occurred. The preceding statements about rates of crack growth apply to all of the disks except the one with low hardness (Rockwell C-11). The cracks in the low-hardness disk progressed
